# SCHOOL FACILITIES ASSESSMENT

Watertown Public Schools, Watertown, Massachusetts

## PRELIMINARY QUALITATIVE EVALUATION DOCUMENT

March 13, 2014

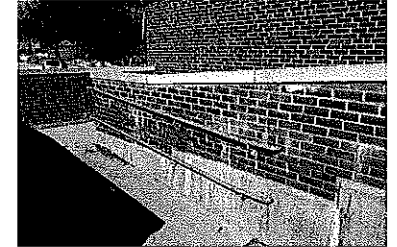
Photo 3

Efflorescence at south entrance site walls (Old Hosmer Building). Red arrow points to location of vertical crack in brick masonry.

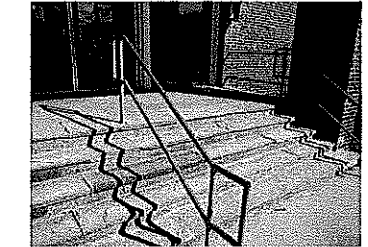
Photo 4

South entrance floor.

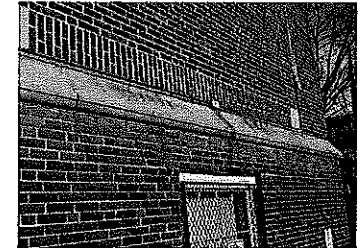
**Photo 3**  
Rusted staining and deteriorated mortar joints at precast band course. Brick masonry below is stained.
